National Dam Inspection Program.
Ringtown Number 6 Dam, Susquehanna
River Basin, Commonwealth of
Pennsylvania, Schuylkill County
(NDS-PA-660). Phase I Inspection Report.

RINGTOWN NO. 6 DAM

PHASE I INSPECTION REPORT

NATIONAL DAM INSPECTION PROGRAM

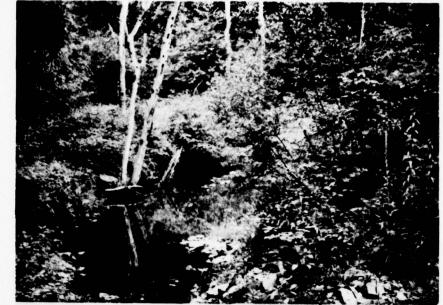
Downstream Channel

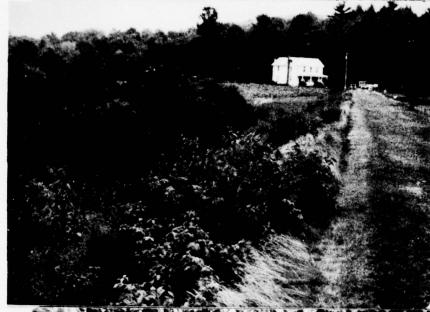
Downstream Slope
